Application of Geophysical Methods in the Investigation of Possible *Lochs* in the Town of Miroslav

During Christmas 2002 the pavement of a yard caved-in, at a private home in the town of Miroslav. The cave-in exposed a cavern under the pavement, 1.5 m in diameter and 6 m deep. Investigation confirmed the hole had opened with the gradual subsidence of soil into the cavern. Indirect evidence resulting from subsequent research supports the possibility that a *loch* existed here in the past, which, at a later date had been turned into a wine cellar.

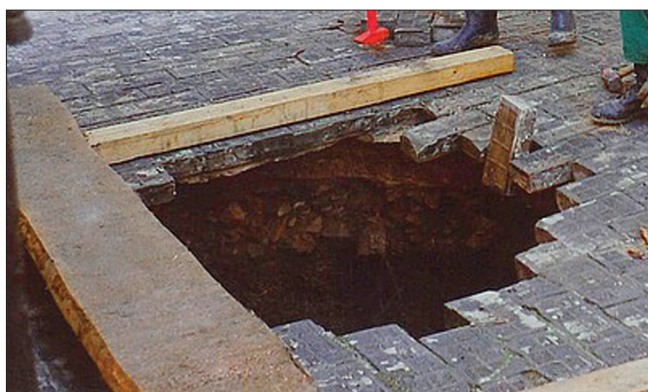
Figure 1. The hole at the location of the collapse.

After the cave-in of part of a yard of a family house (Figure 1), situated at the northern limit of the town of Miroslav, geophysical and sounding investigations were carried out in an effort to detect the existence of similar objects in this part of the town.

In December 2002 the originally intact surface of the central part of the yard of a family house in the town of Miroslav, broke and sank under a relative of the house. A cylindrical cavity appeared, with a diameter of ca 1.5 m and height of 2.6 m. However, in consideration of to the considerable firmness of the pavement, jointed by cement mortar, it is probable that this collapse was not caused immediately after subsidence of the overlaying material into an unknown cavity, but by the breakage of the yard pavement or of the uppermost layers under this paving. An opening of ca 1 m in diameter remained after removing the paving stones from the margins of the hole.

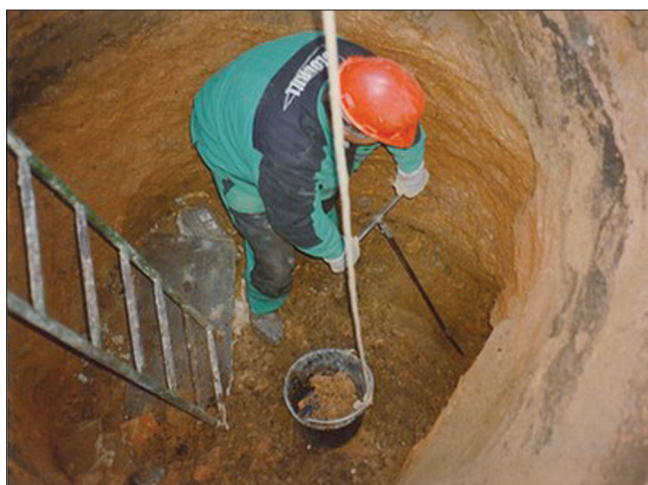
Figure 2. Detail of the works at the bottom of the cavern.

Soundings were conducted in the cavern itself (Figure 2) and its proximity. Georadar profiles were developed on the yard's

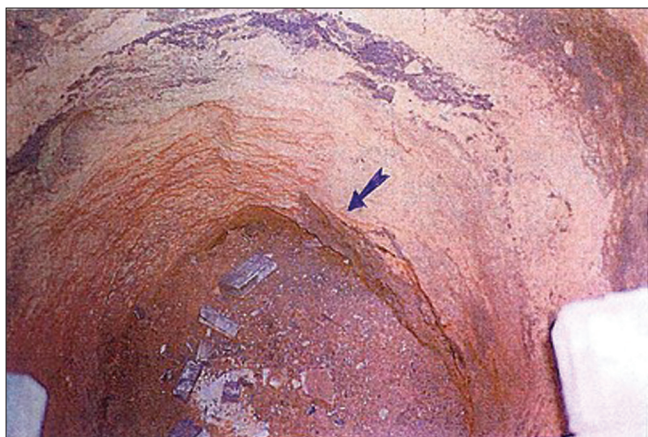
Figure 3. Profile of the cylindrical cavern at its bottom.

The paving around the opening up to the distance of ca 60 cm (even on intact base) is somewhat deformed (we omitting the sloping of the yard surface towards the drain in the south corner of the yard). Base landfills level show signs of gradual subsidence including the existence of older layer of mortar, ca 2 cm thick, located approximately 20 cm under the present surface. The total thickness of the coarse landfill layer under the paving is ca 50 to 60 cm. It can therefore be assumed that, even before the laying of the paving units about 50 years ago, the surface of the yard was sinking gradually in at its central part. In the cylindrical walls of the cavern (Figure 3), there

is no cavity or a relic of a vault apparent. The cylindrical shape of the cavern itself is somewhat atypical, but since it is located in less cohesive soils with distinctive amount of coarser component, such shape is possible (it is sometimes documented also in narrow broken-through passageways). However, according to the amount of sunken (missing) material (ca 6 to 7 m³), the cavity must have been larger or much higher than regular corridor or passageway. The possibility of sinking of the backfill of an old well cannot be definitely excluded, but the well would have to be very deep (15 to 20 m), due to empty volume after compression. There are no traces of digging or walling up apparent on the walls of the cavern. Under the abovementioned coarse landfills, other cultural layers are apparent down to the depth of ca 1.1 m. It has prevalingly character of sandy loams, with ochre and grey to black layers. These loams probably come from the time of adaptation of the terrain for building purposes or may be even older. The base of the landfill consists of ochre Neogène slope clayey loams with a coarsely sandy component. At the bottom of the cavern (Figure 4), reddish coarsely pebbly loams (redeposited basal clastics of the Boskovice Furrow) protrude on the NNE walls. The fracture plane on the clastics is clearly visible. It may be a relic of a wall of unvaulted cavity. In this place the talus cone is also further from the wall. The research was focused into this locality. Near the outcrop of the clastics, in the Neogène soils, intervention into the layers up to the height of ca 30 cm from the bottom of the cavern is very apparent. The buried profile of an older cavity, obviously of anthropogenic origin, is also apparent. The thin upper layer of the backfill, evidently done from inside, consists of greasy carbons, probably a residue of decayed timber. The material of the backfill is formed by sandy rock with gray to black stripes. A typical small cavity, originating from the sinking of the backfill, is missing between the original soil and the top of the backfill. This small cavity, however, may have been reduced gradually by the abovementioned sinking of the soils, including the yard's surface.

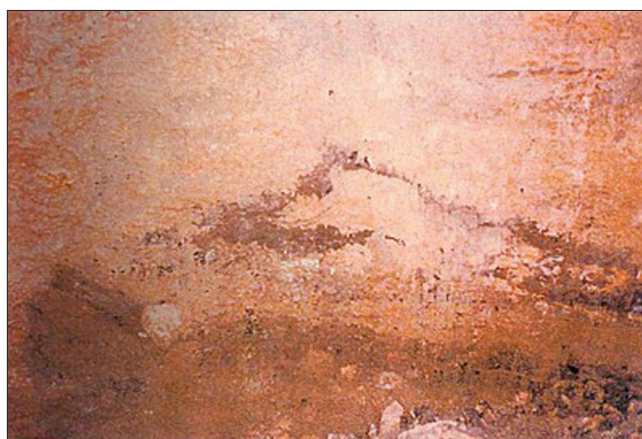
Figure 4. Detail at the bottom of the cavern.

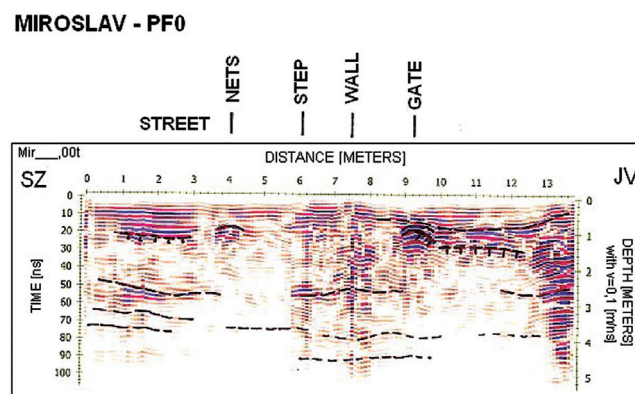
Figure 5. Time cut No. 0 NW-SE.

In the vicinity of the collapse, georadar profiles were developed, along the yard margins and the foot-print of the built-up area (Dostál 2003). Profile 0 (Figure 5) was obtained from the opposite wall across the street into the yard down to the drain. In cross-section it is possible to see reinforcement of the road and water supply line, a step of the sidewalk, peripheral wall, side reflection of the cellar entrance and the drain. The profile of the bottom of backfills is sunk, with irrelevant anomalies. Profiles 1 to 3 were obtained along the circumference of the yard. It is possible to see the boundary line of landfills, side reflection of the cavity on the profile 3: an indication of a buried corridor which corresponds to continuation of the buried corridor by the southeast wall across the cavern. Profile 4 was conducted on Údolní Street along the sidewalk margin, from the wall connecting the
