Survey of Mural Pigment Samples from the Rotunda of Saint Catherine, Znojmo, Czech Republic

The article looks at the evaluation of dating of pigment samples taken from murals in the Rotunda of Saint Catherine in Znojmo, Czech Republic (see Merhautová, Třeštík 1984). The samples were taken on July 11th, 2006 by Petr Kadlec, a restorer and academically trained painter, for the South Moravia Region Art and Monument Preservation Department.

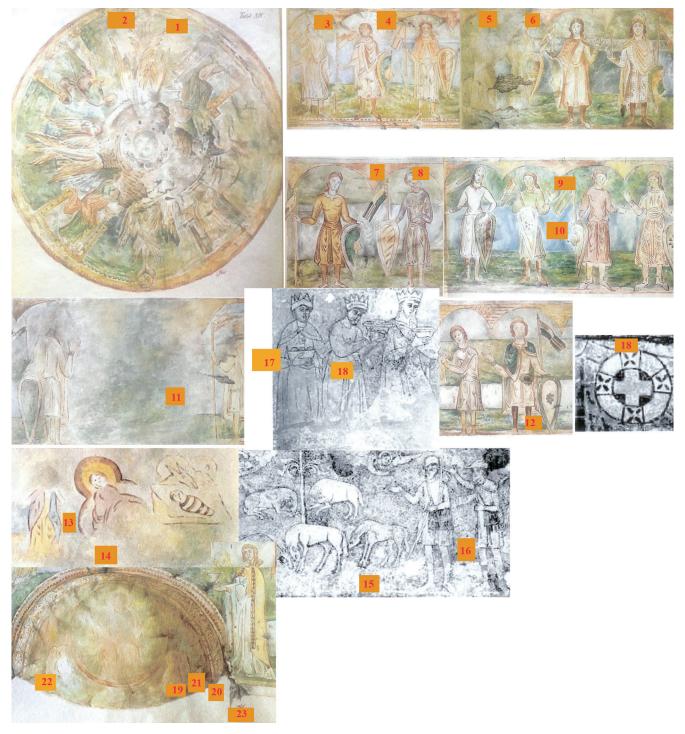
Figure 1. Location of samples, which were used for analysis (drawing M. Trapp, 1862, photo authors' archive).

The samples of the mural were taken on July 11th, 2006, numbered 1–23, and submitted to a laboratory survey (Figure 1).

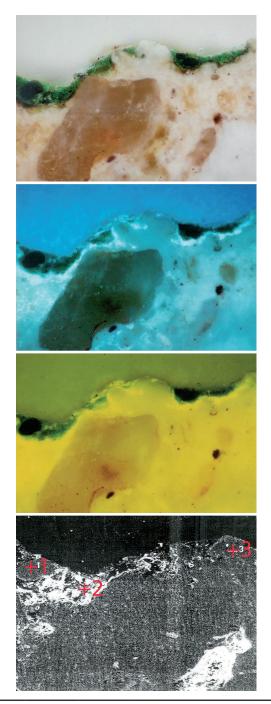
$\label{eq:Figure 2.} \textbf{ Sample 1; green colour-green earth, chrome oxide, barium sulphate, colouring earth, calcium sulphate.}$

- Sample 1 (Figure 2): green colour green earth, chrome oxide, barium sulphate, colouring earth, calcium sulphate.
- Sample 2 (Figure 3): green colour chrome oxide, barium sulphate, colouring earth, calcium sulphate.
- Sample 3 (Figure 4): red colour red ochre, colouring earth, calcium sulphate.

1		2		3
Oxide	Wt [%]	Oxide	Wt [%]	Oxide	Wt [%]
MgO	5.54	Na ₂ O	0.44	MgO	2.99
Al_2O_3	7.38	MgO	2.77	SiO_2	11.08
SiO_2	52.02	Al_2O_3	5.39	SO_3	1.82
K_2O	9.65	SiO_2	33.3	CaO	84.12
Fe ₂ O ₃	25.4	SO_3	13.63		
		K_2O	6.14		
		CaO	3.92		
		BaO	15.34		
		Cr_2O_3	5.01		
		Fe_2O_3	14.05		
Total	100	Total	100	Total	100

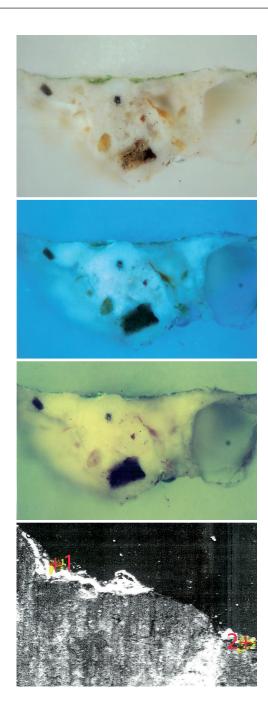
$\begin{tabular}{ll} \textbf{Figure 3.} & Sample 2; green colour - chrome oxide, barium sulphate, colouring earth, calcium sulphate. \end{tabular}$

1	2
Oxide	Wt [%]	Wt [%]
Na ₂ O	0.59	2.74
MgO	0.55	2.33
Al_2O_3	4.3	3.58
SiO_2	25.7	26.06
SO_3	21.84	17.86
K_2O	3.14	5.17
CaO	13.52	4.58
BaO	12.99	15.61
Cr_2O_3	4.98	10.67
Fe_2O_3	12.38	11.41
Total	100	100

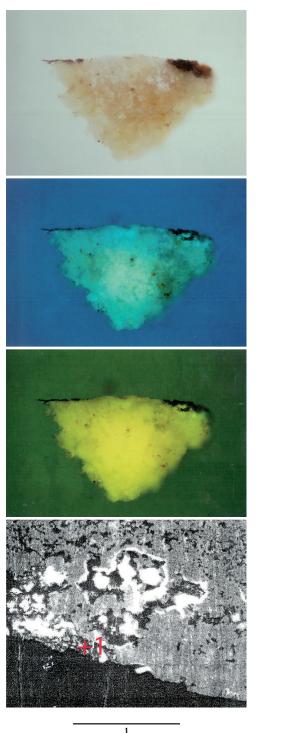
Figure 6. Sample 5; red colour – red ochre, colouring earth, calcium sulphate, zinc white.

1
Oxide	Wt [%]
MgO	1.07
Al_2O_3	2.26
SiO_2	10.62
SO_3	6.85
K_2O	0.58
CaO	4.08
Fe_2O_3	59.4
ZnO	15.15
Total	100

- Sample 4 (Figure 5): yellow colour mars yellow, colouring earth, calcium sulphate.
- Sample 5 (Figure 6): red colour red ochre, colouring earth, calcium sulphate, zinc white.

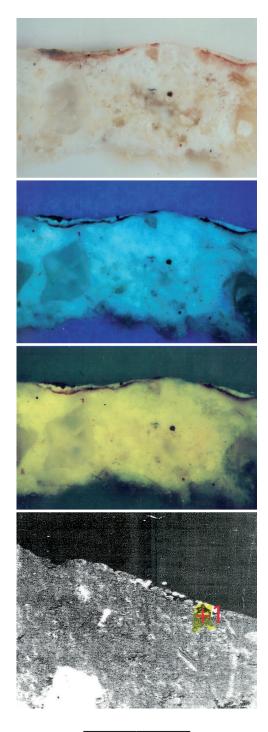
$\begin{tabular}{ll} \textbf{Figure 7.} & \textbf{Sample 6; red colour - red ochre, colouring earth, calcium sulphate.} \end{tabular}$

1
Oxide	Wt [%]
Na ₂ O	0.55
MgO	2.19
Al_2O_3	6.54
SiO_2	11.77
SO_3	15.05
K_2O	1.05
CaO	56.94
Fe_2O_3	5.9
Total	100

- Sample 6 (Figure 7): red colour red ochre, colouring earth, calcium sulphate.
- Sample 7 (Figure 8): red colour red ochre, colouring earth, calcium sulphate.

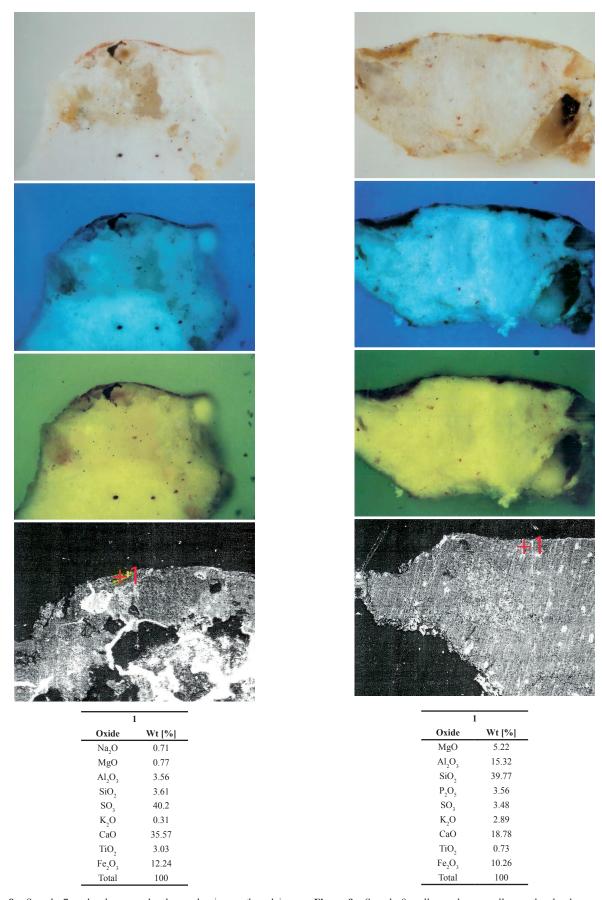
$\begin{tabular}{ll} Figure 9. & Sample 8; yellow colour - yellow and red ochres, colouring earth \\ \end{tabular}$

- Sample 8 (Figure 9): yellow colour yellow and red ochres, colouring earth
- Sample 9 (Figure 10): green colour green earth, chrome oxide (?), barium sulphate, colouring earth, ochres, calcium sulphate.

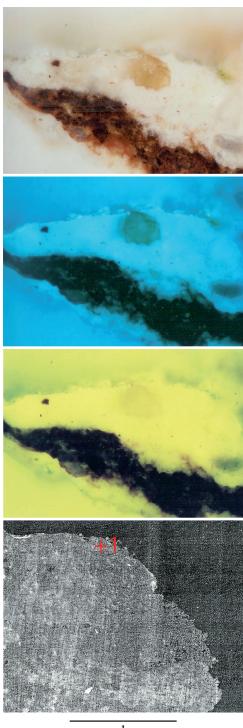
Figure 10. Sample 9; green colour – green earth, chrome oxide (?), barium sulphate, colouring earth, ochres, calcium sulphate.

1
Oxide	Wt [%]
MgO	3.76
Al_2O_3	7.25
SiO,	39.77
SO ₃	14.72
K,O	6.13
CaO	7.88
BaO	7.68
Fe_2O_3	12.81
Total	100

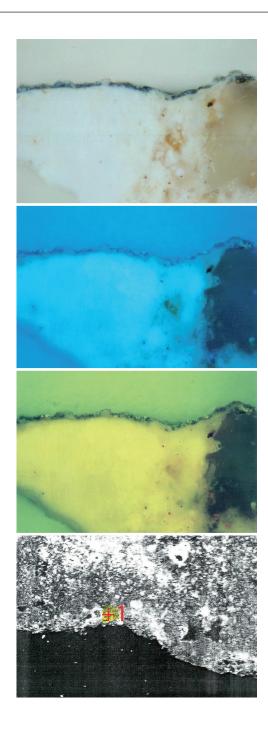
Figure 11. Sample 10; blue colour – artificial ultramarine, colouring earth, ochres, calcium sulphate.

1		
Oxide	Wt [%]	
Al ₂ O ₃	1.48	
SiO_2	2.68	
SO_3	54.99	
CaO	39.77	
Fe_2O_3	1.08	
Total	100

- Sample 10 (Figure 11): blue colour artificial ultramarine, colouring earth, ochres, calcium sulphate.
- Sample 11 (Figure 12): I coating, red colour red ochre, colouring earth, calcium sulphate;

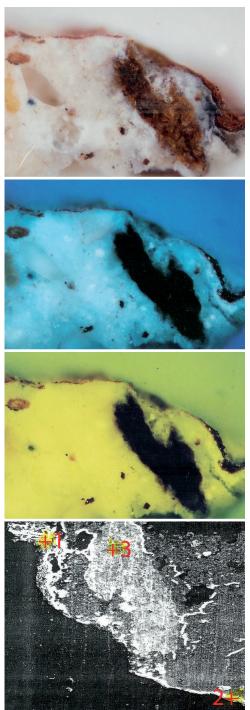
Figure 12. Sample 11; I – coating, red colour – red ochre, colouring earth, calcium sulphate; II – lower coating, red colour – red ochre, colouring earth, cinnabar, chrome.

. i.		4		
				2 -	
			*		
	1		2		3
Oxide	Wt [%]	Oxide	Wt [%]	Oxide	Wt [%]
Al_2O_3	4.57	MgO	0.91	MgO	2.05
SiO_2	1.57	Al_2O_3	12.63	Al_2O_3	22.91
PbO_2	37.8	SiO_2	6.27	SiO_2	34.24
CaO	3.51	SO_3	18.33	SO_3	1.7
Cr ₂ O ₃	4.16	CaO	19.1	K_2O	3.8
Fe_2O_3	48.4	TiO_2	3.84	CaO	1.01
		Fe_2O_3	38.93	Fe_2O_3	34.29
Total	100	Total	100	Total	100

- II lower coating, red colour red ochre, colouring earth, cinnabar, chrome.
- Sample 12 (Figure 13): red colour cinnabar.
- Sample 13 (Figure 14): blue colour artificial ultramarine, colouring earth, ochres, calcium sulphate.

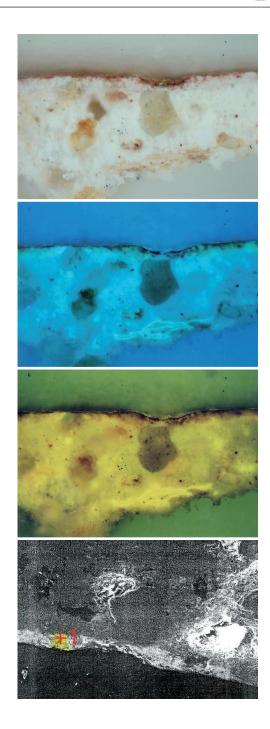
Figure 13. Sample 12; red colour – cinnabar.

1
Oxide	Wt [%]
CaO	3.06
PbO	96.94
Total	100

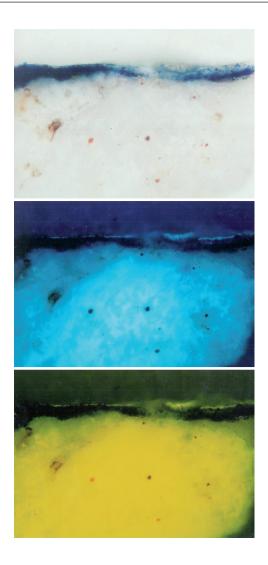
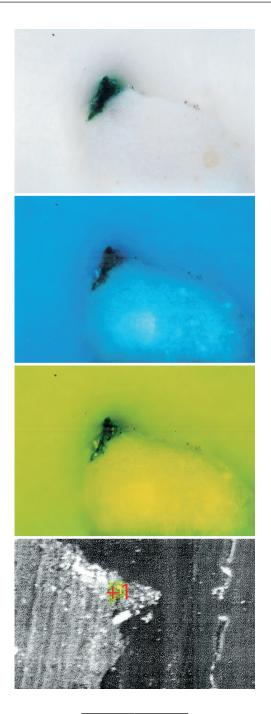
Figure 14. Sample 13; blue colour – artificial ultramarine, colouring earth, ochres, calcium sulphate.

1		
Oxide	Wt [%]	
MgO	1.47	
Al_2O_3	3.94	
SiO_2	11.24	
P_2O_5	4.2	
SO_3	16.77	
K_2O	1.96	
CaO	46.72	
BaO	2.65	
Cr_2O_3	5.29	
Fe_2O_3	5.75	
Total	100

Figure 15. Sample 14; green colour – chrome oxide, barium sulphate, colouring earth, ochres, calcium sulphate.

- Sample 14 (Figure 15): green colour chrome oxide, barium sulphate, colouring earth, ochres, calcium sulphate.
- Sample 15 (Figure 16): green colour green earth, chrome oxide, calcium sulphate

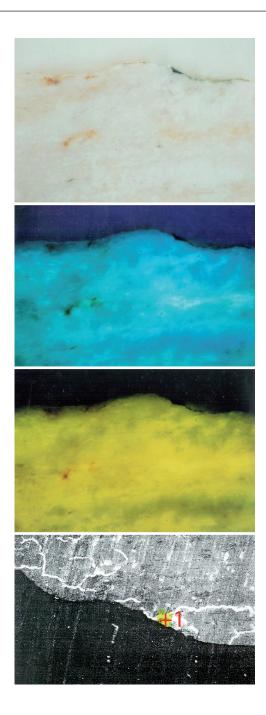
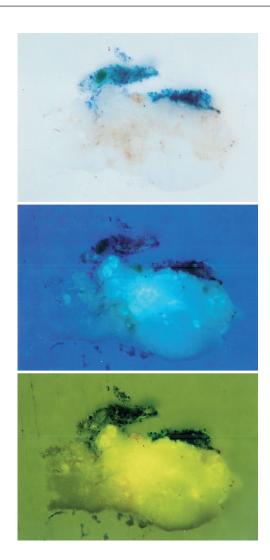
Figure 16. Sample 15; green colour – green earth, chrome oxide, calcium sulphate.

1
Oxide	Wt [%]
MgO	2.39
Al_2O_3	11.74
SiO_2	22.55
SO_3	17.09
K_2O	3.29
CaO	31.55
BaO	1.44
Cr_2O_3	3.03
Fe_2O_3	6.91
Total	100

Figure 17. Sample 16; blue colour – artificial ultramarine, colouring earth, ochres, calcium sulphate.

- Sample 16 (Figure 17): blue colour artificial ultramarine, colouring earth, ochres, calcium sulphate.
- Sample 17 (Figure 18): blue colour artificial ultramarine, colouring earth, ochres, calcium sulphate.

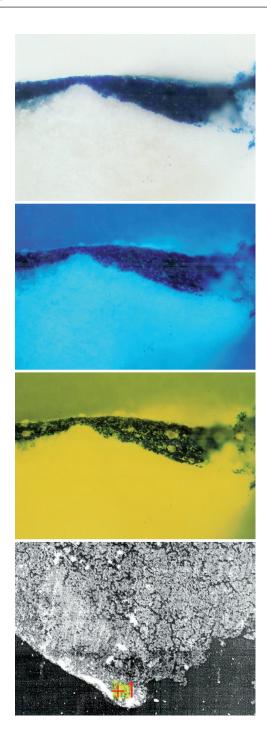
Figure 18. Sample 17; blue colour—artificial ultramarine, colouring earth, ochres, calcium sulphate.

1		
Oxide	Wt [%]	
Na ₂ O	9.85	
MgO	2.03	
Al_2O_3	15.05	
SiO_2	38.97	
SO_3	18.91	
K_2O	4.9	
CaO	3.28	
Fe_2O_3	7.01	
Total	100

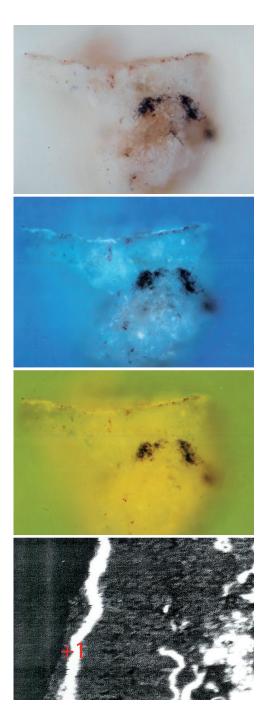
Figure 19. Sample 18; red colour – red ochre, colouring earth, calcium sulphate, zinc white.

_	
	1
Oxide	Wt [%]
Na ₂ O	1.99
MgO	3.52
Al_2O_3	1.54
SiO_2	11.29
P_2O_5	17.79
SO,	11.67
K,O	1.13
CaO	48.47
Fe,O,	2.62
Total	100

- Sample 18 (Figure 19): red colour red ochre, colouring earth, calcium sulphate, zinc white.
- Sample 19 (Figure 20): yellow colour zinc white, colouring earth, ochres, calcium sulphate.

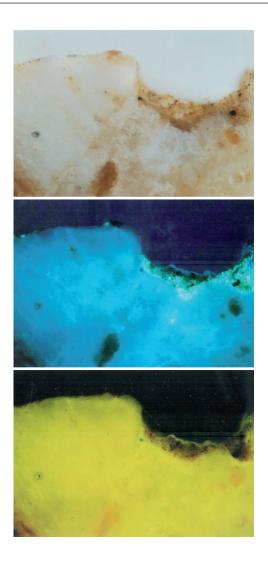
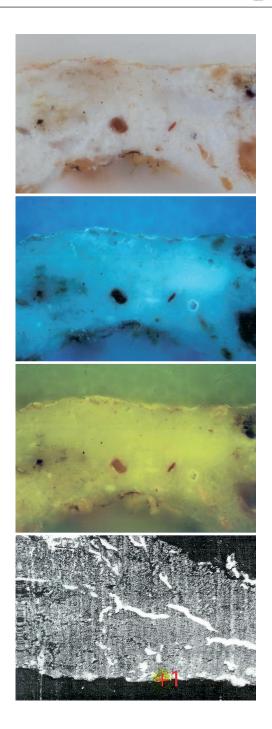
Figure 20. Sample 19; yellow colour – zinc white, colouring earth, ochres, calcium sulphate.

1				
Oxide	Wt [%]			
Na ₂ O	1.05			
MgO	0.7			
Al_2O_3	5.48			
SiO_2	10.57			
SO_3	27.89			
K_2O	1.42			
CaO	44.68			
Cr_2O_3	1.22			
Fe_2O_3	7.01			
Total	100

Figure 21. Sample 20; red colour – red ochre, colouring earth, calcium sulphate, chrome (green granule).

- Sample 20 (Figure 21): red colour red ochre, colouring earth, calcium sulphate, chrome (green granule).
- Sample 21 (Figure 22): I layer, ochre colour titanium white and zinc white, colouring earth, ochres, calcium sulphate; II lower layer, blue colour (with green) artificial ultramarine; III lower layer, green colour Schweinfurt green, chrome oxide, barium sulphate, colouring earth, ochres, zinc white, calcium sulphate.

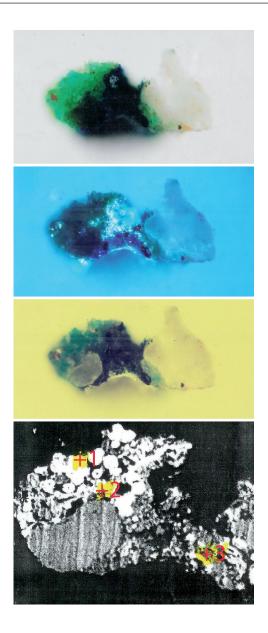
Figure 23. Sample 22; I – coating, green colour – Schweinfurt green, chrome oxide, barium sulphate, colouring earth, ochres, zinc white, slug, calcium sulphate; II – Lower layer, blue colour – artificial ultramarine, colouring earth, ochres, calcium sulphate.

1		2		3	
Oxide	Wt [%]	Oxide	Wt [%]	Oxide	Wt [%]
CuO	33.8	Al_2O_3	2.19	Al_2O_3	20.53
As_2O_3	66.2	SiO_2	11.26	SiO_2	33.46
		P_2O_5	1.47	SO_3	23.19
		SO_3	3.68	K_2O	2.58
		K_2O	3.28	CaO	4.07
		CaO	5.45	Fe_2O_3	0.99
		BaO	3.65	CuO	3.58
		Cr_2O_3	5.17	ZnO	7.81
		Fe_2O_3	11.42	As_2O_3	3.8
		CuO	8.04		
		ZnO	7.33		
		PbO_2	37.07		
Total	100	Total	100	Total	100

- Sample 22 (Figure 23): I coating, green colour Schweinfurt green, chrome oxide, barium sulphate, colouring earth, ochres, zinc white, slug, calcium sulphate; II Lower layer, blue colour artificial ultramarine, colouring earth, ochres, calcium sulphate.
