INTERDISCIPLINARIA ARCHAEOLOGICA

Archaeological and Geophysical Investigation and 3D Visualization at the Jánský Vrch Castle in Javorník (Czech Republic)

An archaeological investigation realized between 2002 and 2012 has re-interpreted the construction phases and spatial organization of the Javorník Castle in Czech Silesia. Its first phase, dating to the beginning of the 14th century, consisted of a bergfried-type castle with a rounded fortification ditch. This fortification was re-built at the end of the 15th and start of the 16th centuries when the castle was divided into upper and lower portions. The Modern Age has seen a complex of constructions at the glaciis, pictured also in historical vedutas. Between 2013 and 2014, certain data acquired earlier by archaeological prospecting and excavations were corroborated by electric resistivity tomography (ERT) and ground penetrating radar measurement (GPR); moreover an advanced siege fortification, probably related to a Hussite siege of the castle, was identified by 3D laser scanning south of the castle.

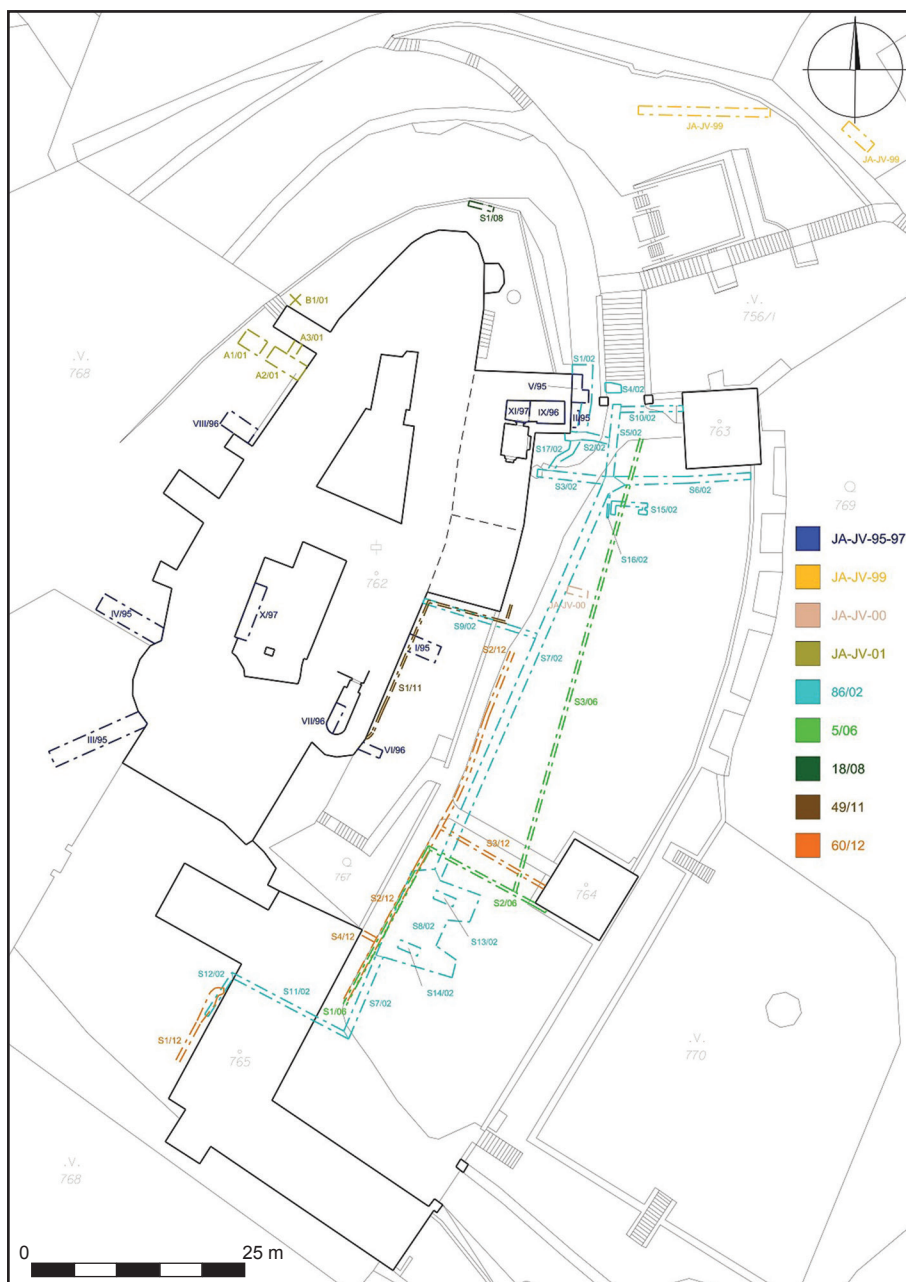
Figure 2. Javorník, Janský Vrch – overview of archaeological activities in the castle area from 1995 to 2012.

Archaeological finds were made at the site already in the 1930s but a systematic investigation only took place after 1990 in relation to construction history research of the chateaux (e.g. Brachtel 1998; 2000). An archaeological salvage excavation took place in 2001 and 2002 along with some sewer reconstruction at the eastern glacis (Figure 2; in greater detail in Dehnerová, Šlězár 2013).

An up-to-date archaeological investigation has revealed that the oldest activities at the castle date from the 14th century, which is in accordance with its supposed foundation at the beginning of the 14th century. In the first phase (14th–15th century), a castle of a bergfried type was built, fortified by a curved ditch (for more details see Dehnerová, Šlězár, in press). In the northern part of the eastern glacis, outside of the ditch, buildings connected with the defence of the castle's entrance have also been identified (Figures 2 and 7). A stone

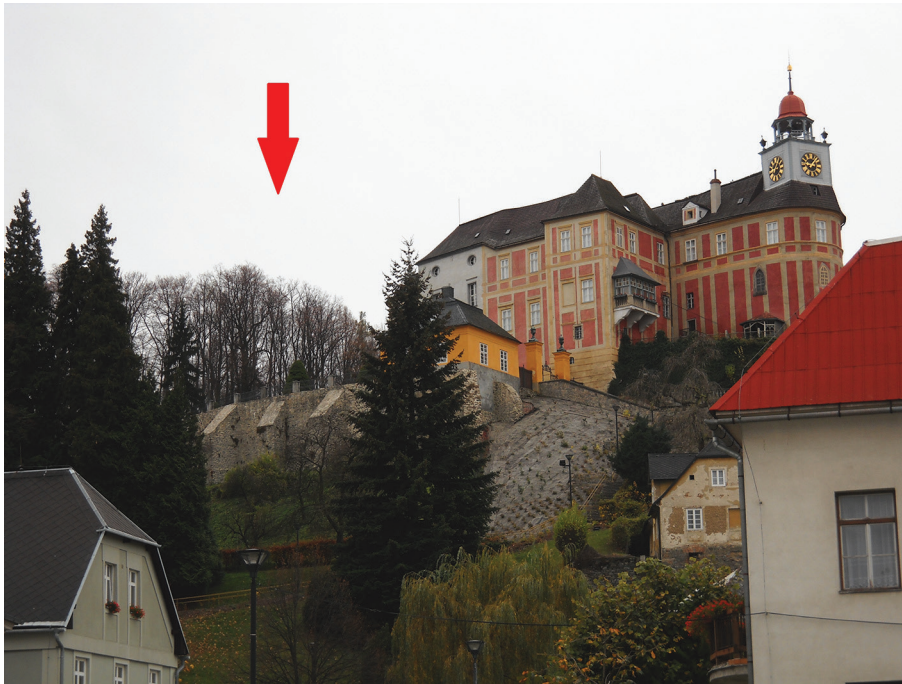
Figure 3. Javorník, Janský Vrch, view from NE. The arrow marks the area of 3D scanning.

We also focused on the flat area south of the castle (Figure 3). Behind the medieval ditch, the terrain rises steeply and turns into a plateau overlooking the entire castle.

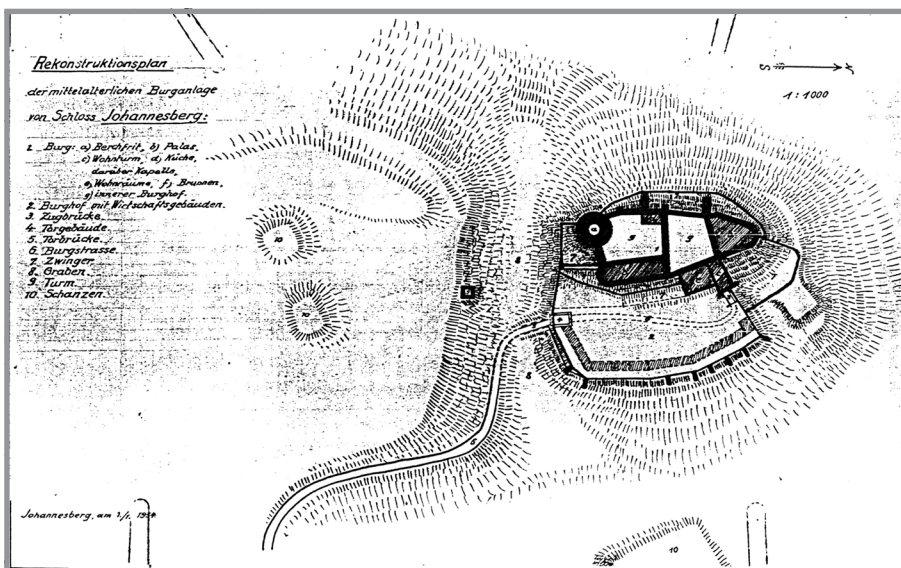
Figure 4. Reconstruction of the medieval castle area, 1934.

This plateau, however, is dotted by terrain bumps. Already in the 1930s, two of these bumps were recorded in a drawing and identified as “Schanzen” (Figure 4; Anonymous 1934). Thus 3D laser scanning was applied to verify the presence and course of any fortification remnants. Results from the measurements made it possible to create a digital model of the terrain (Martínek 2014). The data were acquired by a private company through ground laser scanning, using the FARO FOCUS 3D scanner with a reach of 130 metres, a resolution of <2 mm and scanning speed of 976,000 points per second. Each point on the surface was characterized by three coordinates and also by its colour, reflecting the intensity of the received signal. In this way, a cloud of 1,159,214,300 points was acquired, referenced to 5 fixed

elevations the size of 12×20 and 10×15 m, about 25 m apart (Figures 8 and 9). Their situation answers to the drawing from 1934 (Figure 4). In contrast to that drawing, further terrain modifications became evident thanks to the laser scanning.

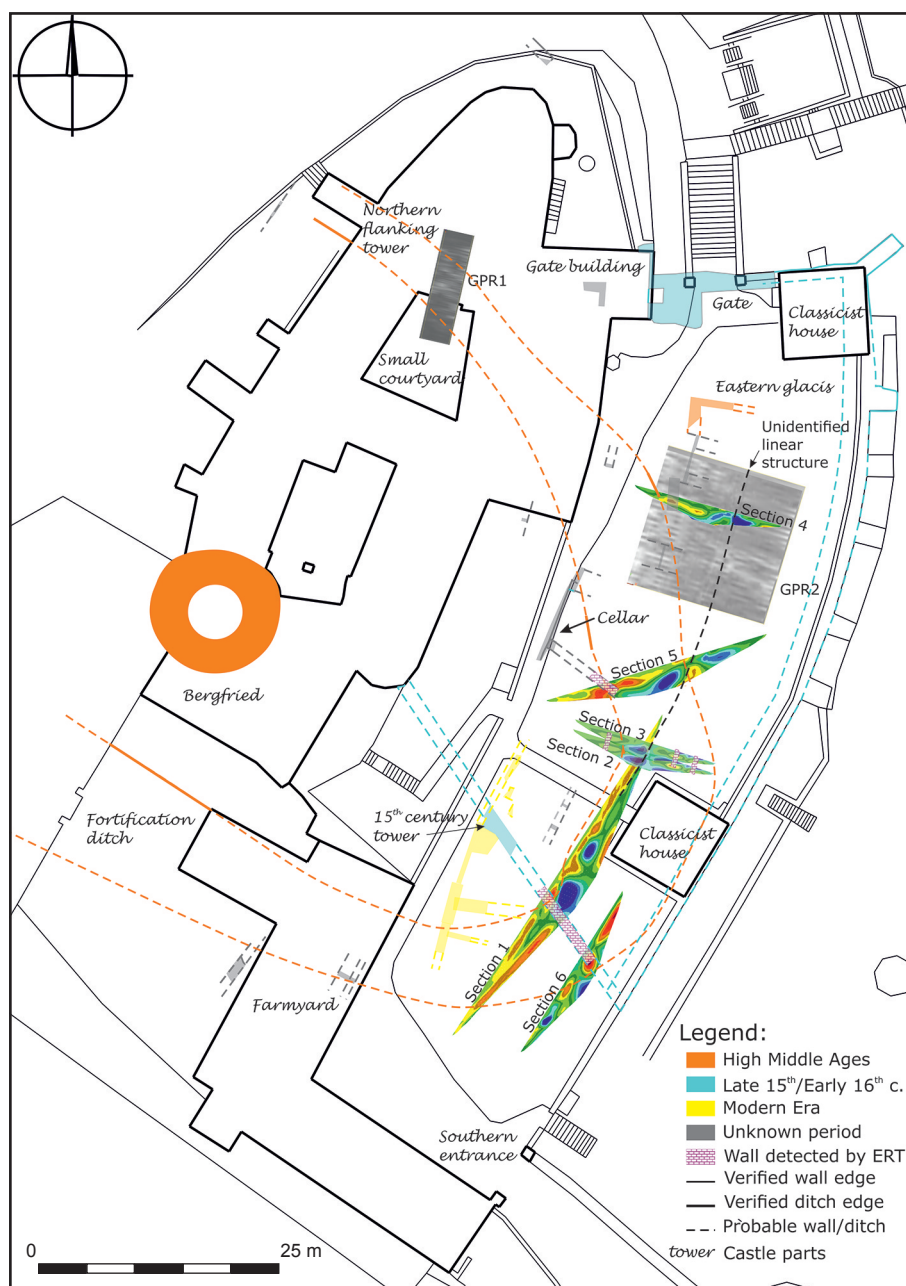
Figure 7. Plan of ERT and GPR measurements, course of supposed High Middle Ages fortification ditch, different parts of the castle mentioned in text, and structures unearthed by archaeological excavation.

building had stood here, a part of which was unearthed close to the north-eastern corner of the castle (Figure 7), and to the north there had stood another wooden and earthen construction as indicated by a fire destruction layer there.

Two linear structures identified in the 15×15 m GPR Probe 2 in the eastern glacis are of unknown function so that they can be classified just as "linear structures" (Figure 7). Their course does not answer to the medieval ditch, they are, however, parallel to the defensive wall from the 15th or 16th century. Whether they formed part of the defensive system or not is, as yet, unclear, as is their age. The eastern structure is more significant: as was also detected by the ERT measurement (see below).

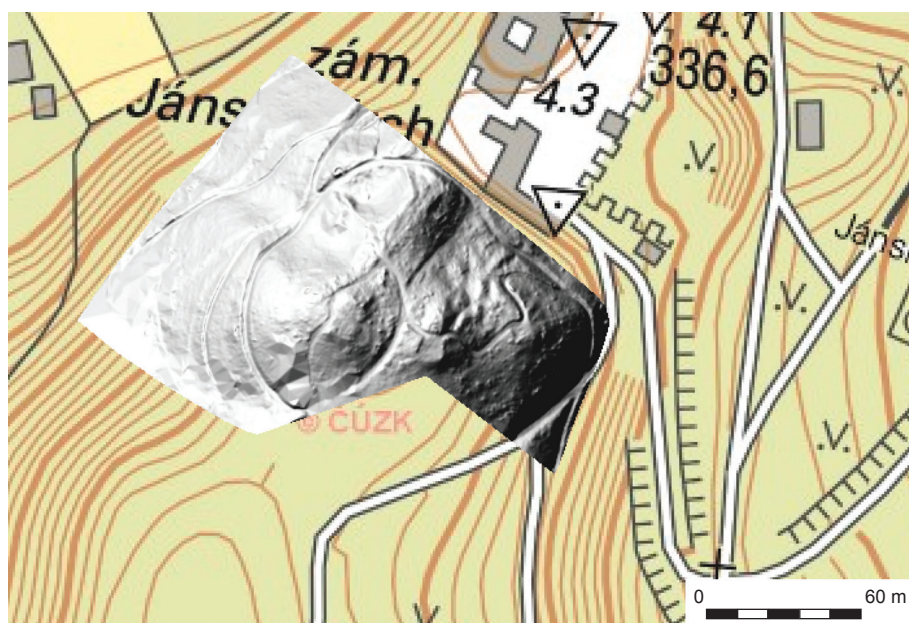
The 3D laser scanning was suitable for the imaging of even the slightest terrain irregularities within the large areas. The images acquired through 3D laser scanning on the plateau south of the castle visualized two irregularly rectangular

Figure 8. Shaded relief acquired by interpolation of 3D laser scanning. Angle of exposure: 315°; Z factor: 4.

The 3D laser scanning of the terrain south of the castle (Figure 8) not only confirmed visual prospecting undertaken earlier but also made the shapes recorded in drawing in 1934 and in the contour mapping of 1991 more precise (Vozda 1991). Most of the recorded irregularities are likely park tracks and paths. More interesting are less pronounced terrain irregularities along the edge of the plateau, between the elevations and the northern edge of the plateau (Figure 9). These may represent remnants of a lighter fortification of the plateau. Even though the elevations are considered to be of medieval age in the reconstruction from 1934, it cannot be excluded that they are Modern Age structures originating from Romantic era modifications of the chateaux gardens (all above the eastern elevation; Figure 9:B). More probable, however, is that they are of medieval origin. Their form (including the lines of possible light fortification) and situation close to the ditch in front of the core of the castle may be related to fortification works. Historical records of the castle's history indicate the diocese castle was besieged between 1428 and 1434 by the Hussites. Archaeological excavation undertaken close to the northern flanking tower in 2001 demonstrated battle activities from around this period, most probably from the spring of 1428 (Kouřil 2009). It is quite possible the plateau had been fortified by this time, forming either an advanced fortification of the castle or the siege camp of the Hussites. Archaeological excavation is required to confirm or disprove these possibilities.

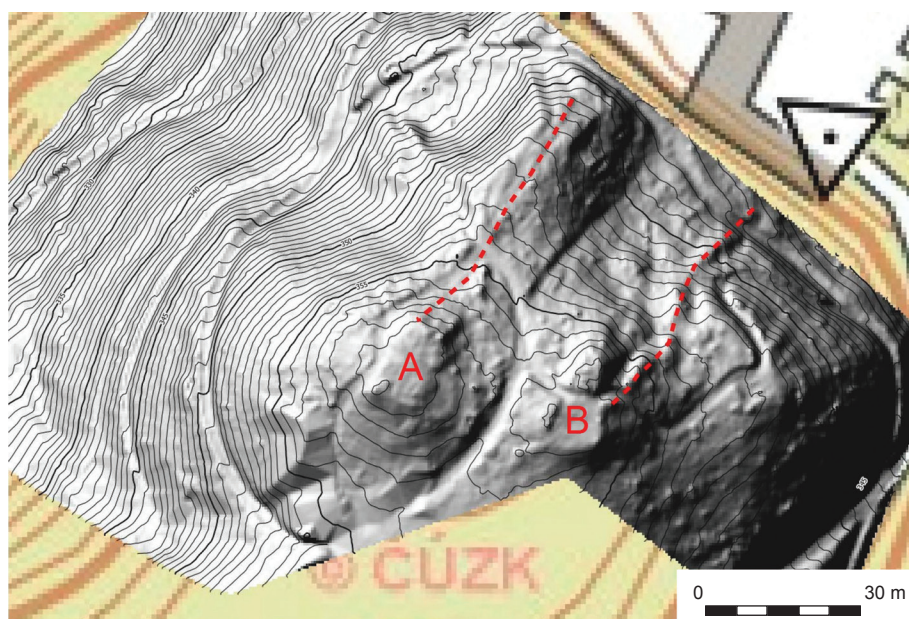
Figure 9. Interpolated image of elevations (A, B) and terrain remnants of a supposed light fortification south of the castle. Angle of exposure: 315°.

Prospecting with 3D laser scanning identified several irregularities on the hill south of the castle. Two parallel lines south of two prominent elevations within the hill represent

either an amplification of the medieval castle or a siege fortification related to the Hussite siege of Javorník in the spring of 1428.
